Smoke and Dye Testing Summary

High Level Sewershed

Test ID	Test Type	Date Inspected	Company / Super.	Blower MH	Ground Condition	Notification Made?	Total Length
S1028-281	Smoke	9/9/2009	ADS/TM	S11KK1002MH	Dry	Yes	944.30

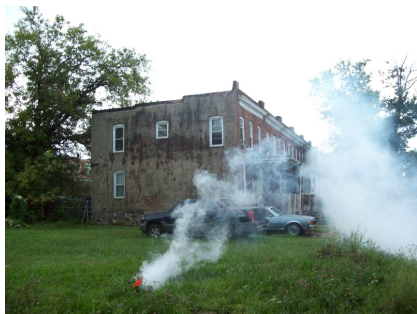
Picture \S1028-281-OB01-P01.jpg

Comments Smoke from cleanout in field. 3315 Dupont Ave.

Comments Front of lot, 3315 Dupont Ave.

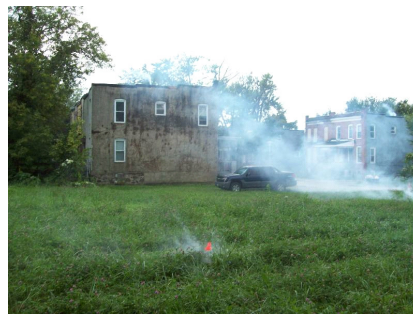
Picture \S1028-281-OB02-P01.jpg

Comments Smoke from service lateral in field. 3313 Dupont Ave.

Comments Front of lot, 3313 Dupont Ave.

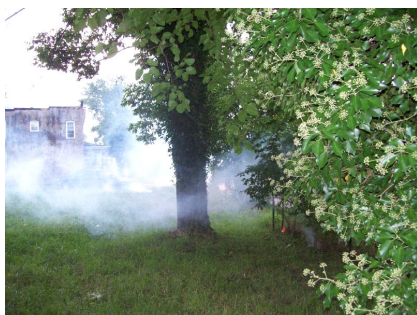
Picture \S1028-281-OB03-P01.jpg

Comments Smoke from cleanout in field. 3311 Dupont Ave.

Comments Front of lot, 3311 Dupont Ave.

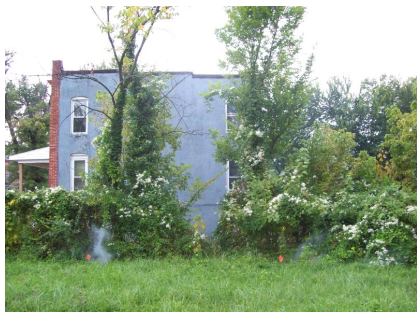
Picture \S1028-281-OB05-P01.jpg

Comments Smoke from service lateral in field. 3322 Dupont Ave.

Comments South side of lot, 3322 Dupont Ave.

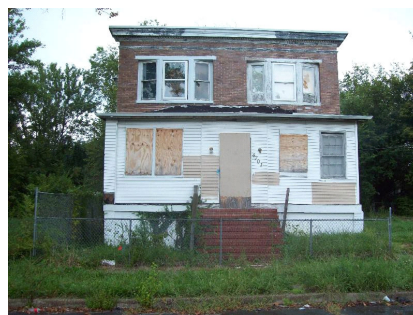
Picture \S1028-281-OB04-P01.jpg

Comments Smoke from cleanout in front yard. 4701 Homer Ave.

Comments Front of house, 4701 Homer Ave.

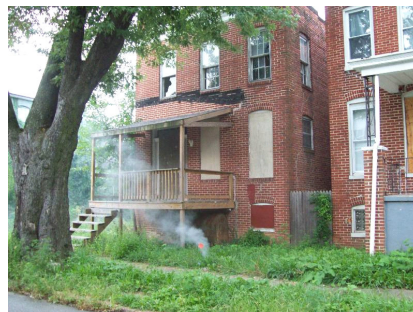
Picture \S1028-281-OB06-P01.jpg

Comments Smoke from cleanout in front yard. 3412 Dupont Ave.

Comments Front of house, 3412 Dupont Ave.

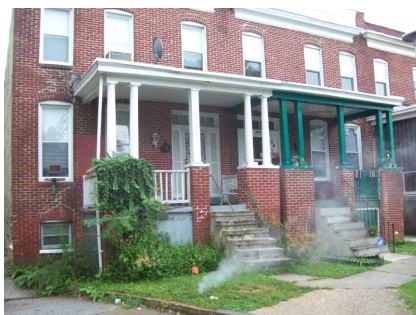
Picture \S1028-281-OB07-P01.jpg

Comments Smoke from cleanout in front yard. 3421 Dupont Ave.

Comments Front of house, 3421 Dupont Ave.

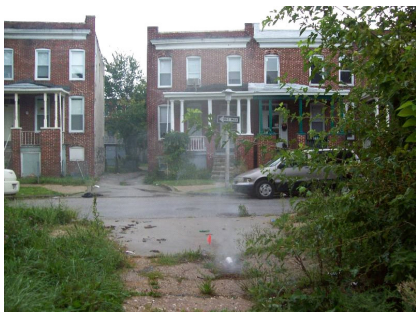
Picture \S1028-281-OB09-P01.jpg

Comments Smoke from catch basin in alley behind 3416 Dupont Ave.

Comments Alley behind 3416 Dupont Ave. looking east

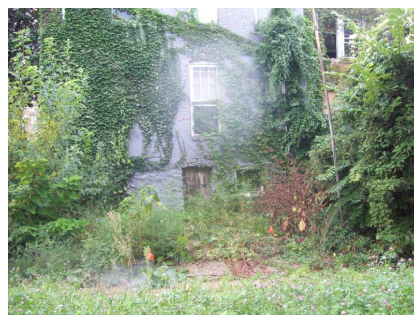
Picture \S1028-281-OB08-P01.jpg

Comments Smoke from storm drain under alley behind 3416 Dupont Ave.

Comments Back of house, 3416 Dupont Ave.

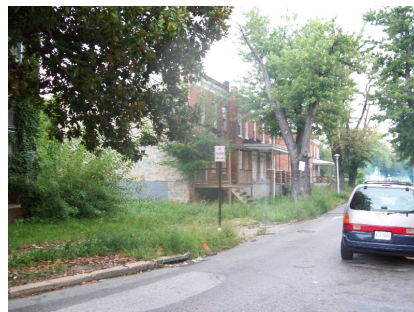
Picture \S1028-281-OB10-P01.jpg

Comments Smoke from catch basin along curb at side of 3416 Dupont Ave.

Comments Side yard, 3416 Dupont Ave.

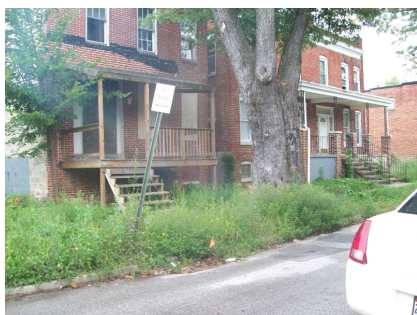
Picture \S1028-281-OB11-P01.jpg

Comments Smoke from catch basin along curb in front of 3414 Dupont Ave.

Comments Front of house, 3414 Dupont Ave.
